Architectural Survey of Pershing Elementary School, Fort Leonard Wood, Missouri

Sunny E. Adams and Adam D. Smith

August 2013

Final Report

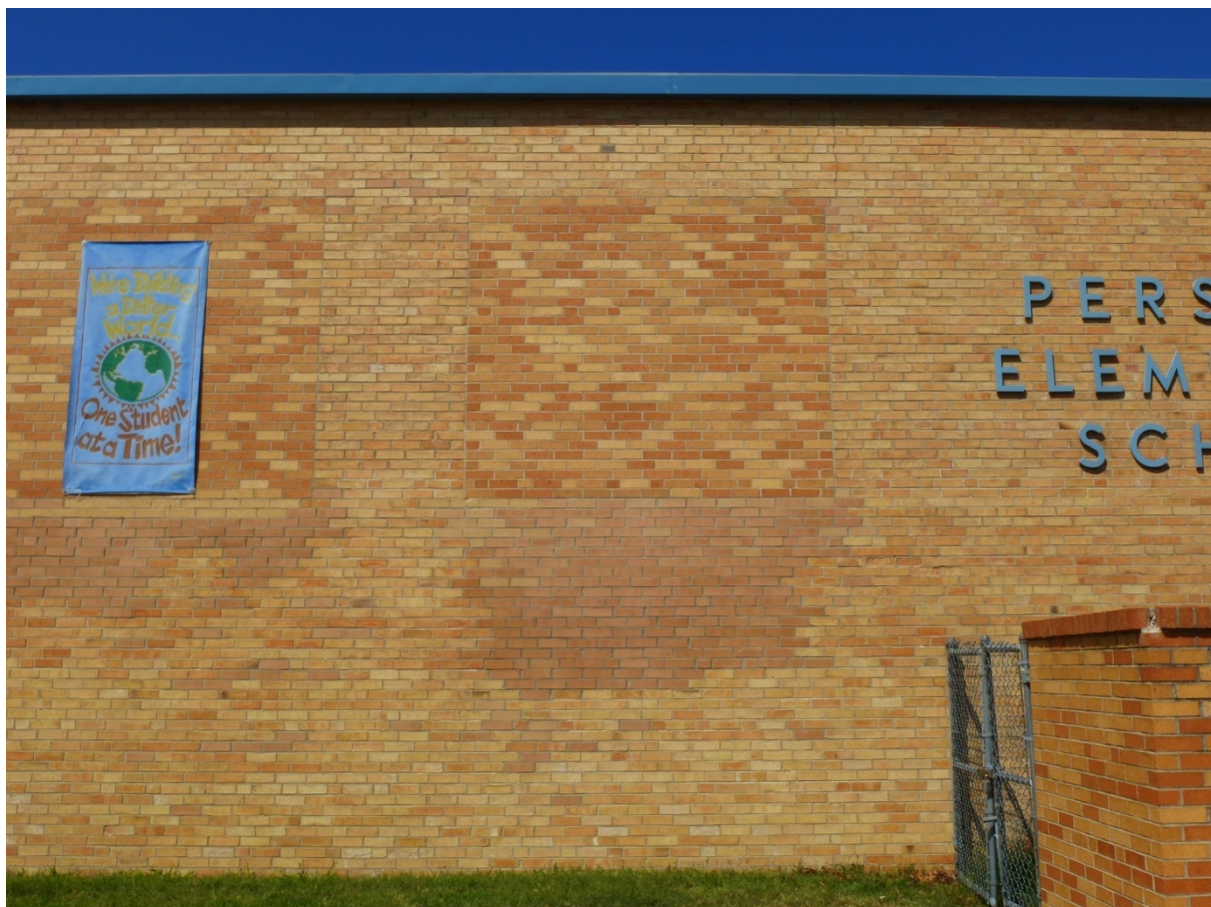
Photo 6. Closeup of the modified window openings on the left side of the east elevation (ERDC-CERL, 2012).

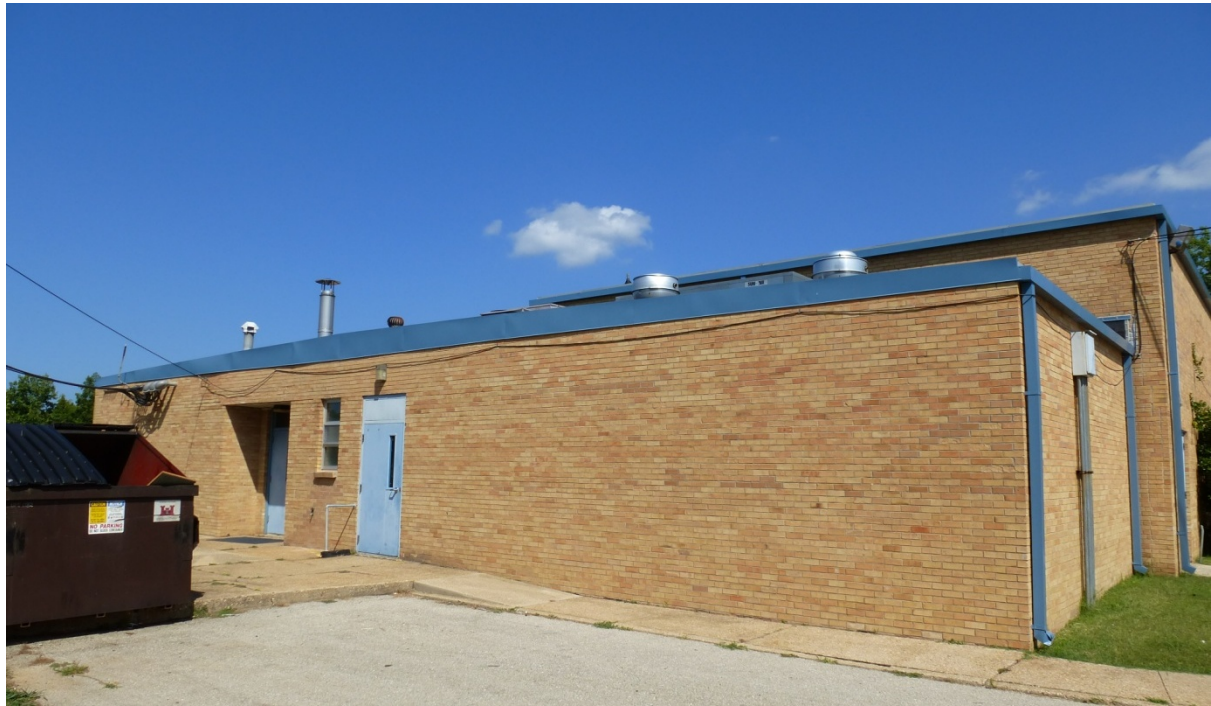
Photo 9. Southeast corner of original school (ERDC-CERL, 2012).

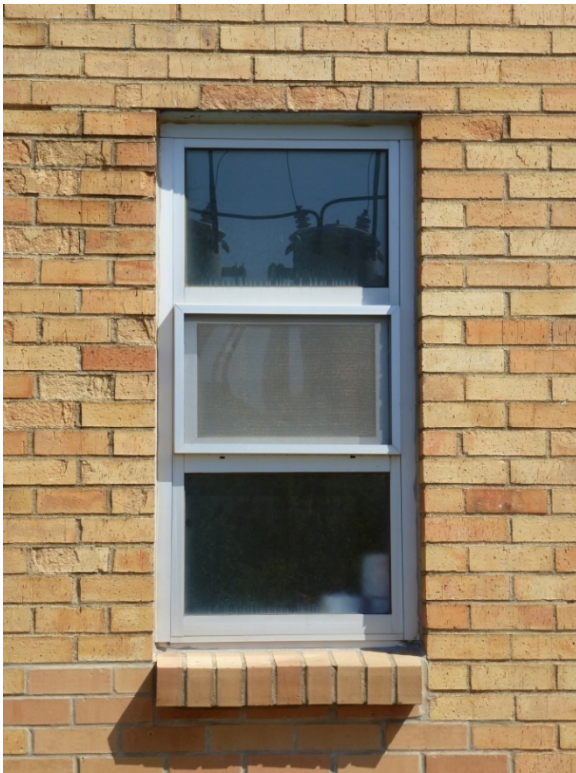
Photo 11. Closeup of replacement bright aluminum three-pane awning window (ERDC-CERL, 2012).

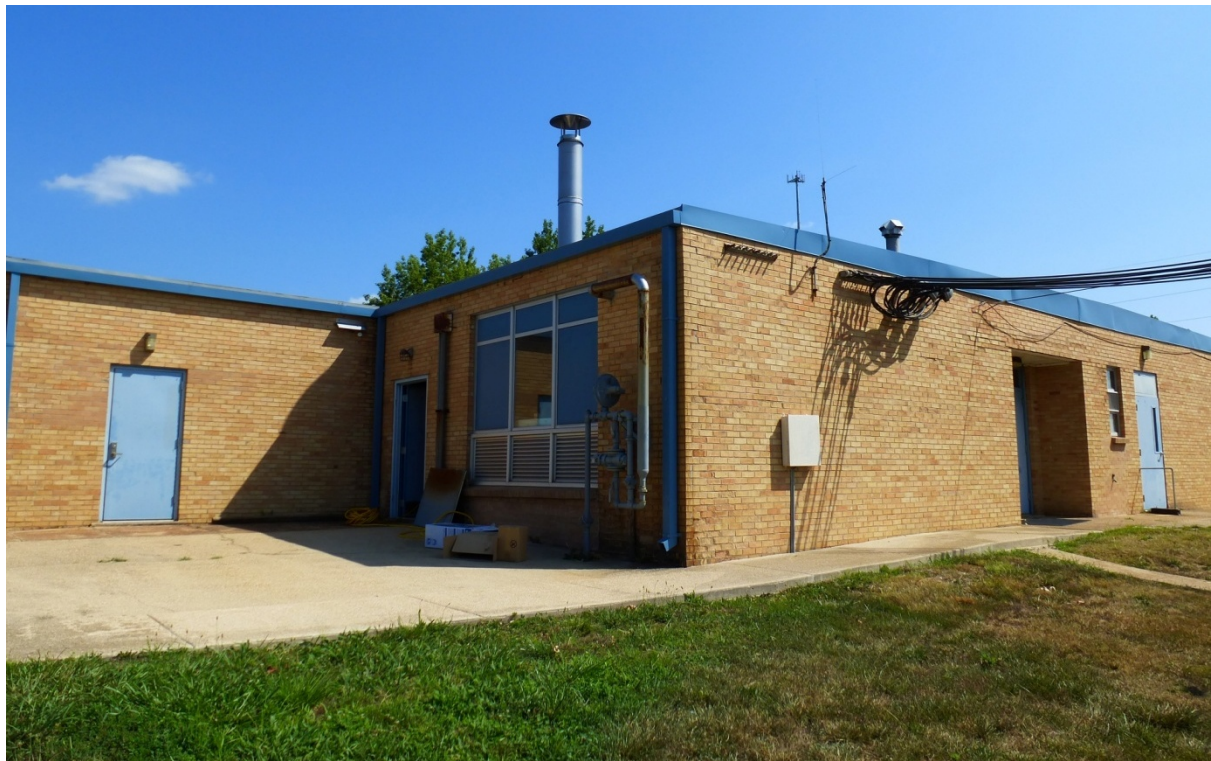
Photo 13. Looking at the exterior of the boiler room on the south elevation (ERDC-CERL, 2012).

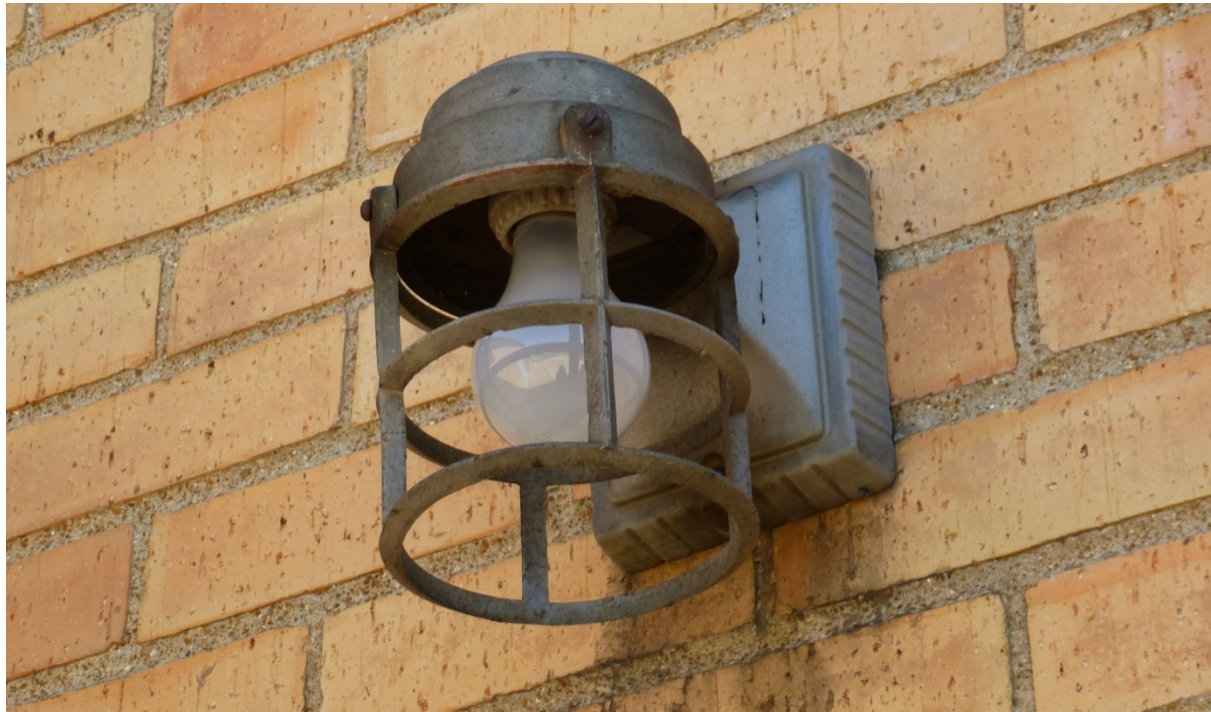
Photo 17. Original light fixture above the door on the far right side of the west elevation (ERDC-CERL, 2012).

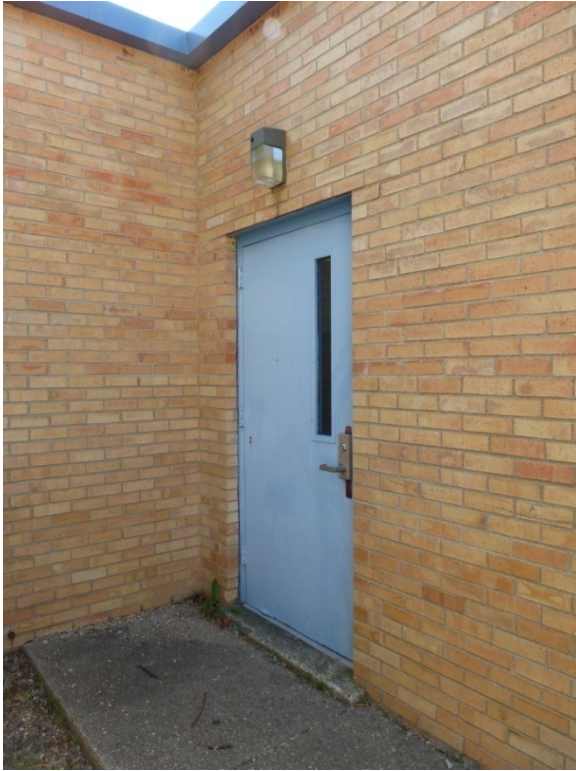
Photo 21. Replacement metal door and replacement light fixture on the west elevation (ERDC-CERL, 2012).

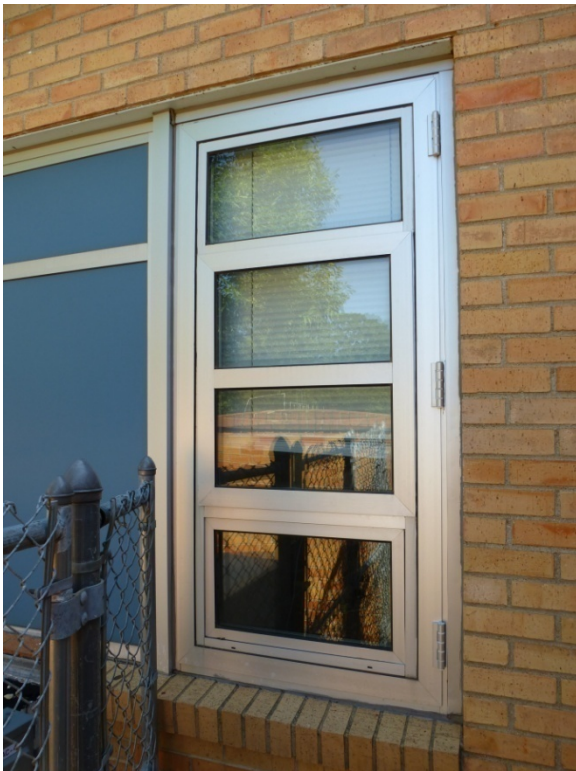
Photo 22. Closeup of replacement bright aluminum egress window (ERDC-CERL, 2012).

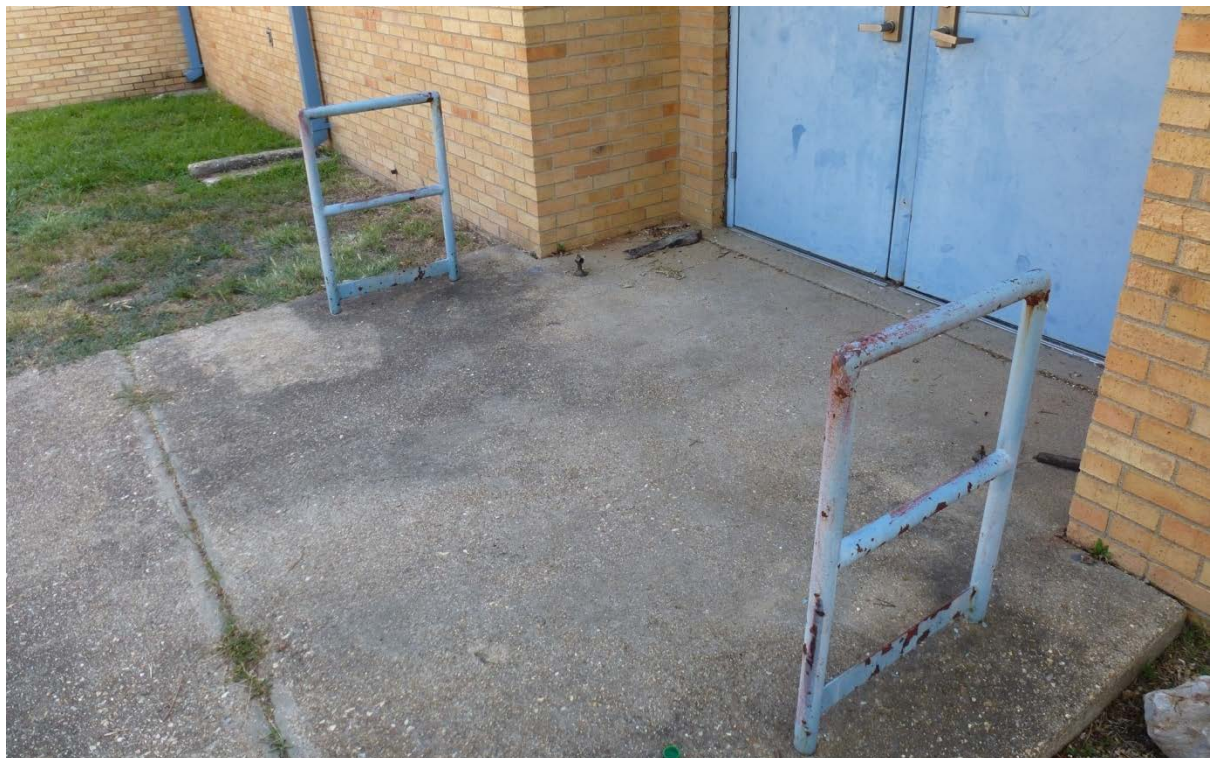
Photo 24. Original “mudscrapers” for shoes located near the entry on the west elevation (ERDC-CERL, 2012).

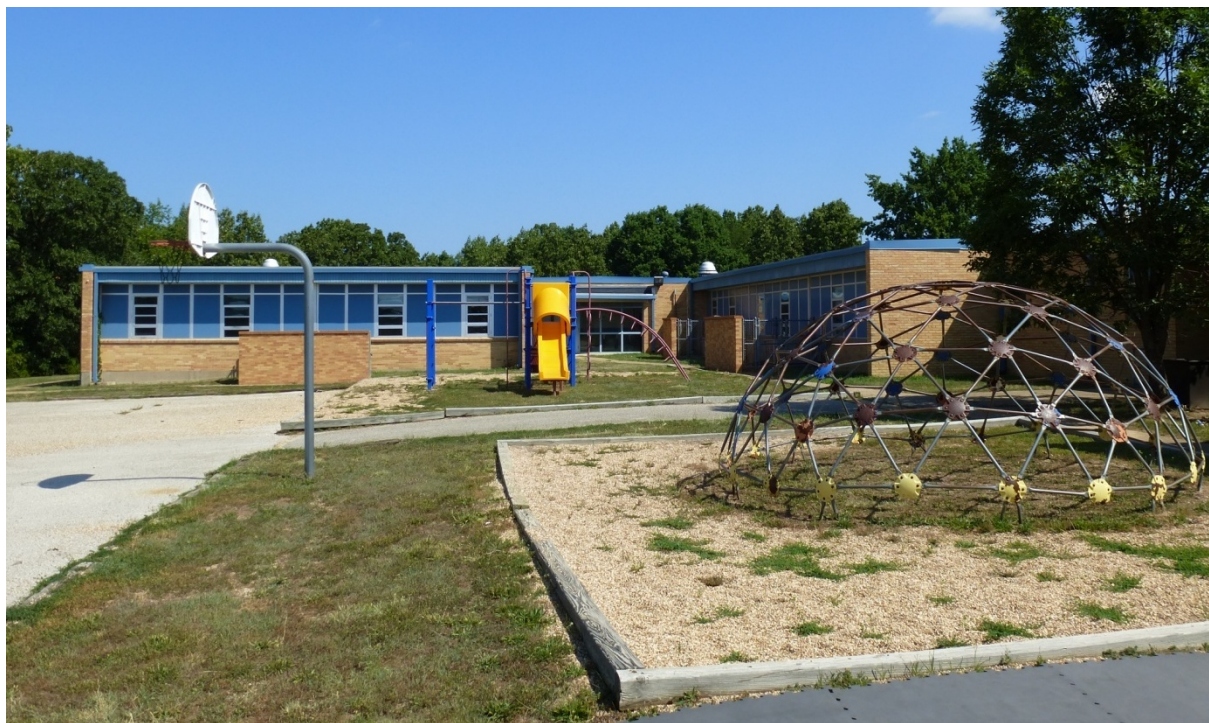
Photo 27. Looking north toward both the 1957 (left) and 1984 (right) additions (ERDC-CERL, 2012).

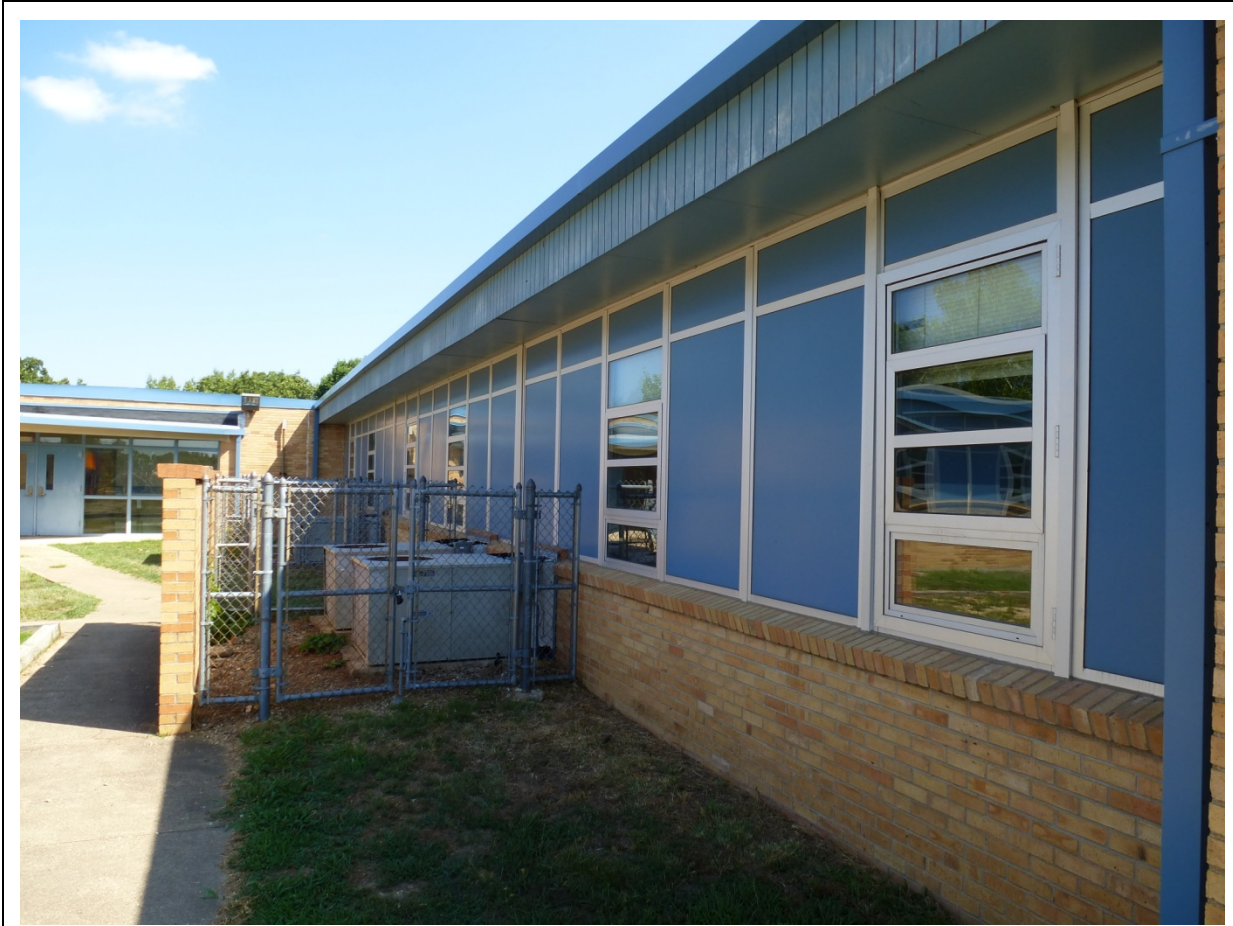
Photo 28. Modified window pattern on the far left side of original west elevation (ERDC-CERL, 2012).

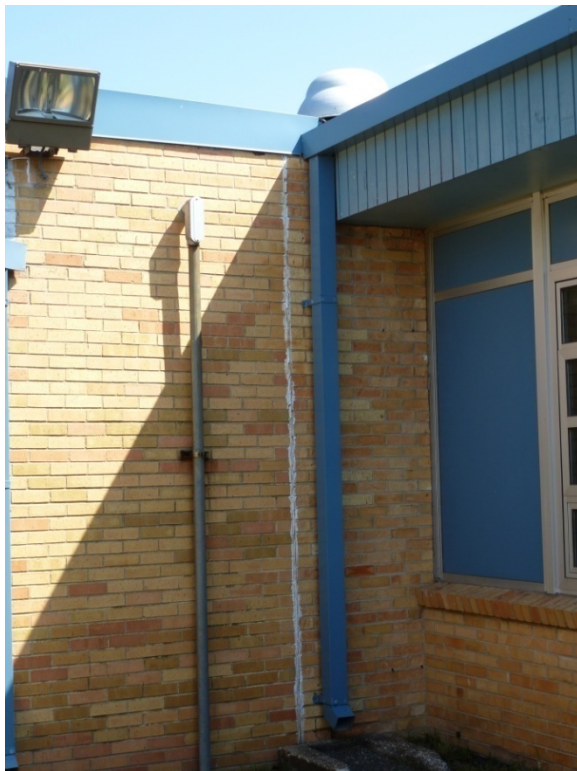
Photo 30. Close-up of connection between the original exterior wall on the west elevation (right side) and the brick wall of the 1957 addition (on the left) (ERDC-CERL, 2012).

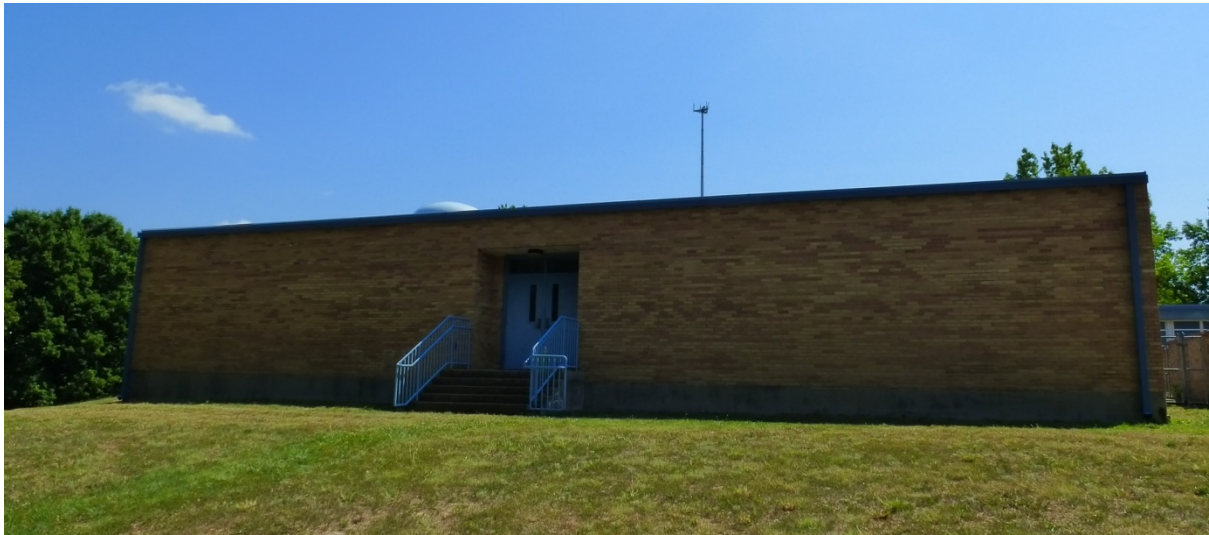
Photo 33. West elevation of 1984 addition (ERDC-CERL, 2012).

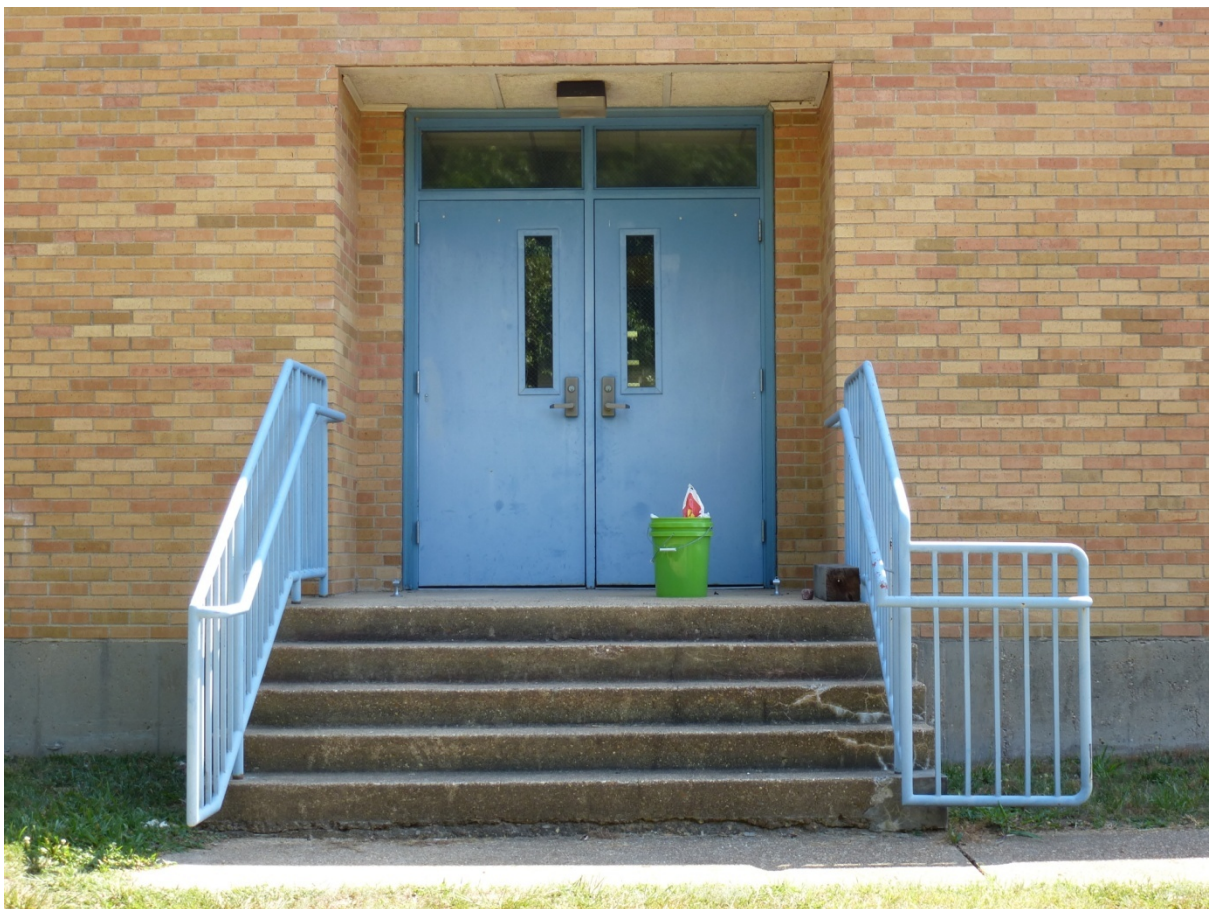
Photo 34. Replacement entry doors on the west elevation of 1984 addition with original metal handrails (ERDC-CERL, 2012).

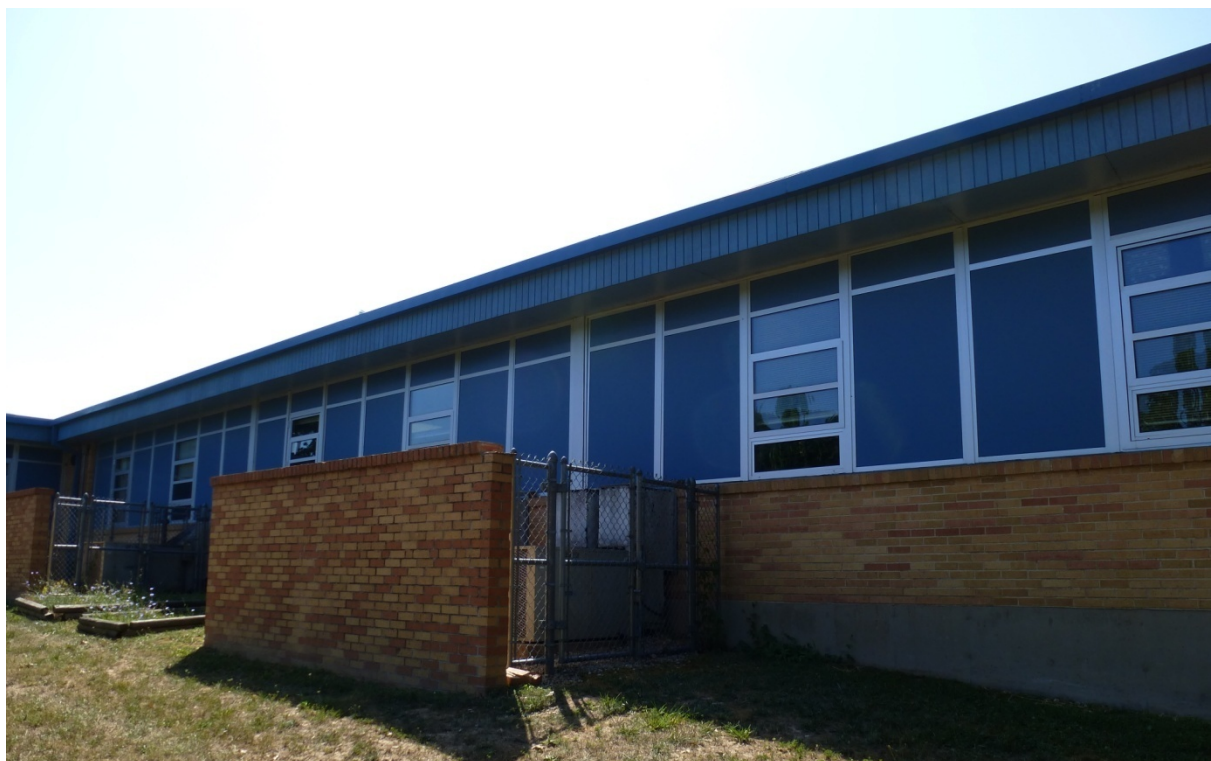
Photo 36. Right side of the north elevation with modified window pattern. Left side is 1957 addition and right side 1984 addition (ERDC-CERL, 2012).

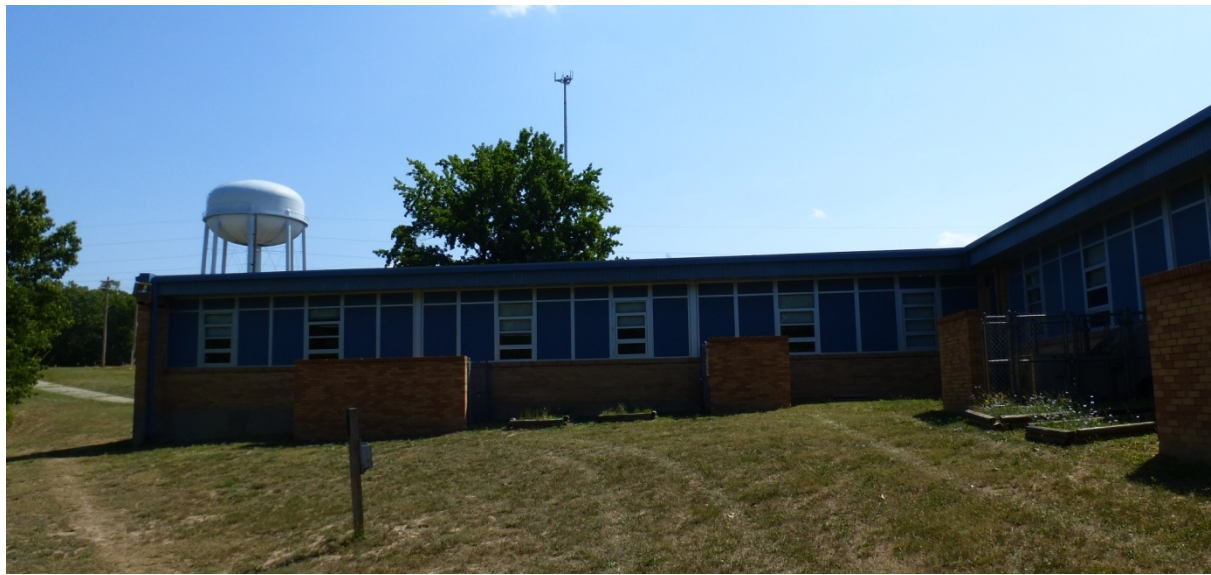
Photo 37. Left side of the west elevation of the 1957 addition with modified window pattern (ERDC-CERL, 2012).

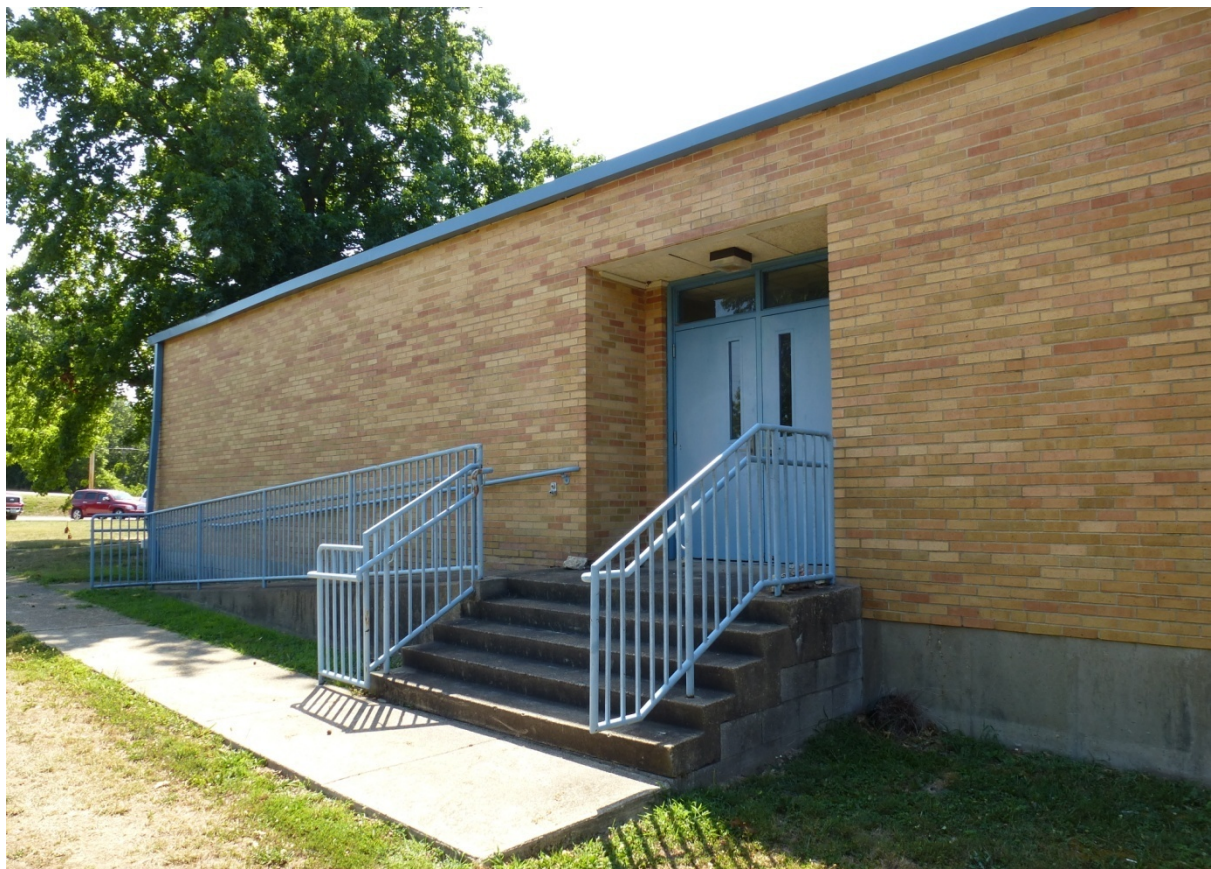
Photo 38. North elevation of 1957 addition with replacement entry doors (ERDC-CERL, 2012).

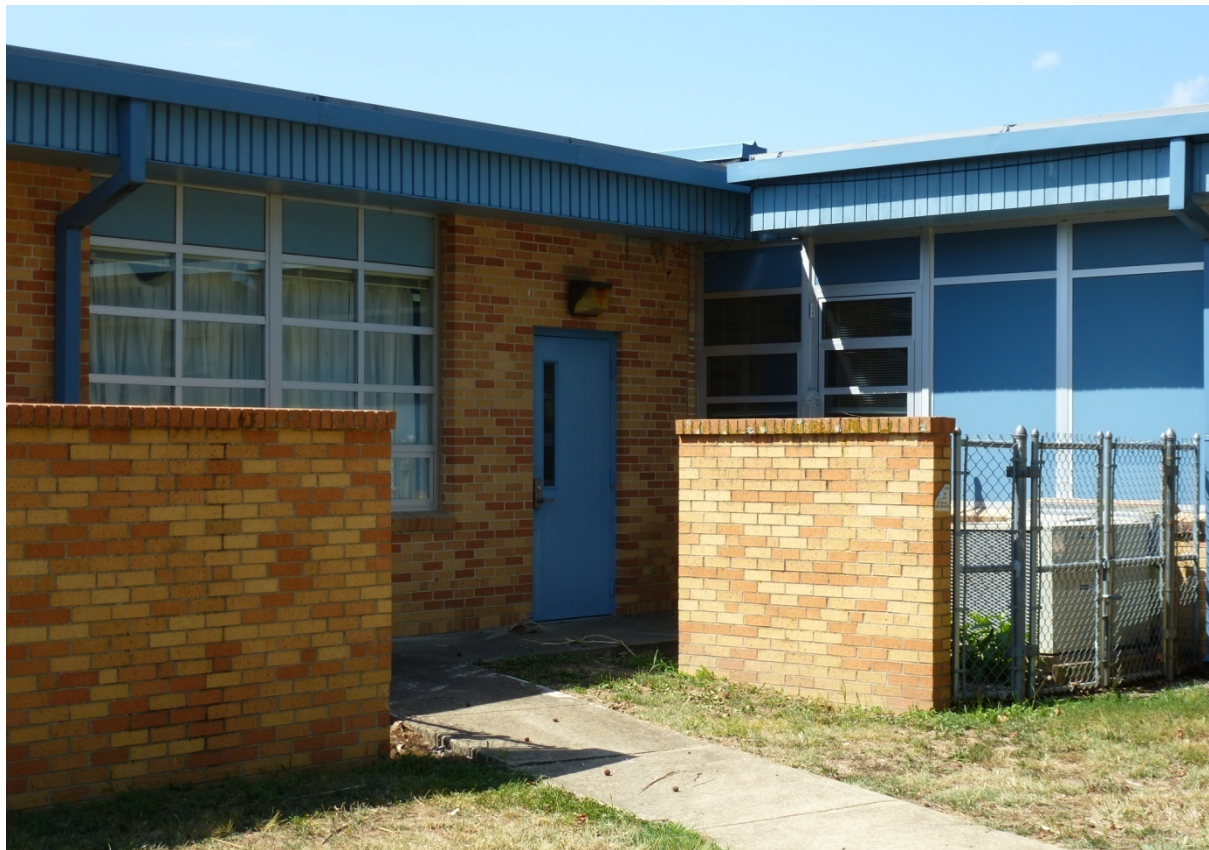
Photo 41. Closeup of connection between the 1957 addition (right side) and 1984 addition (left side) (ERDC-CERL, 2012).

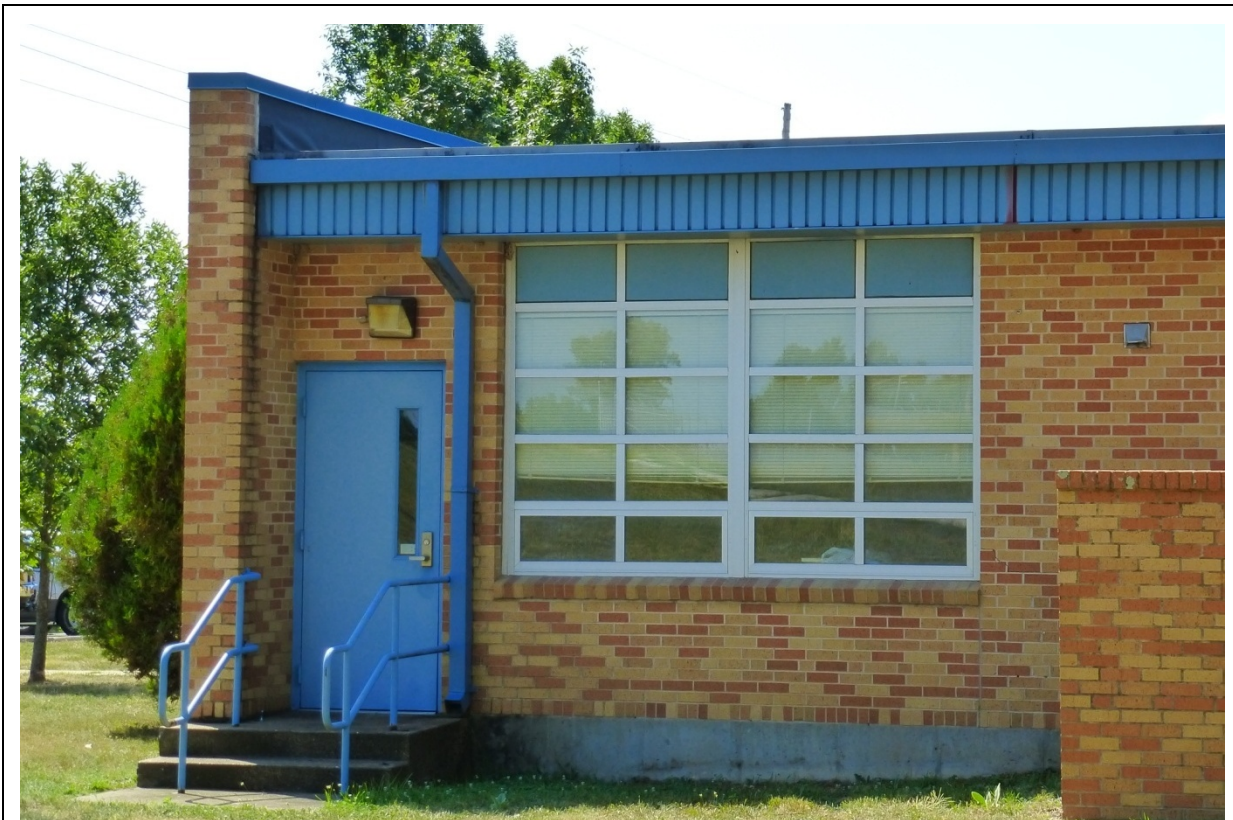
Photo 43. Left side of the north elevation of the 1984 addition with original windows and entry door (ERDC-CERL, 2012).

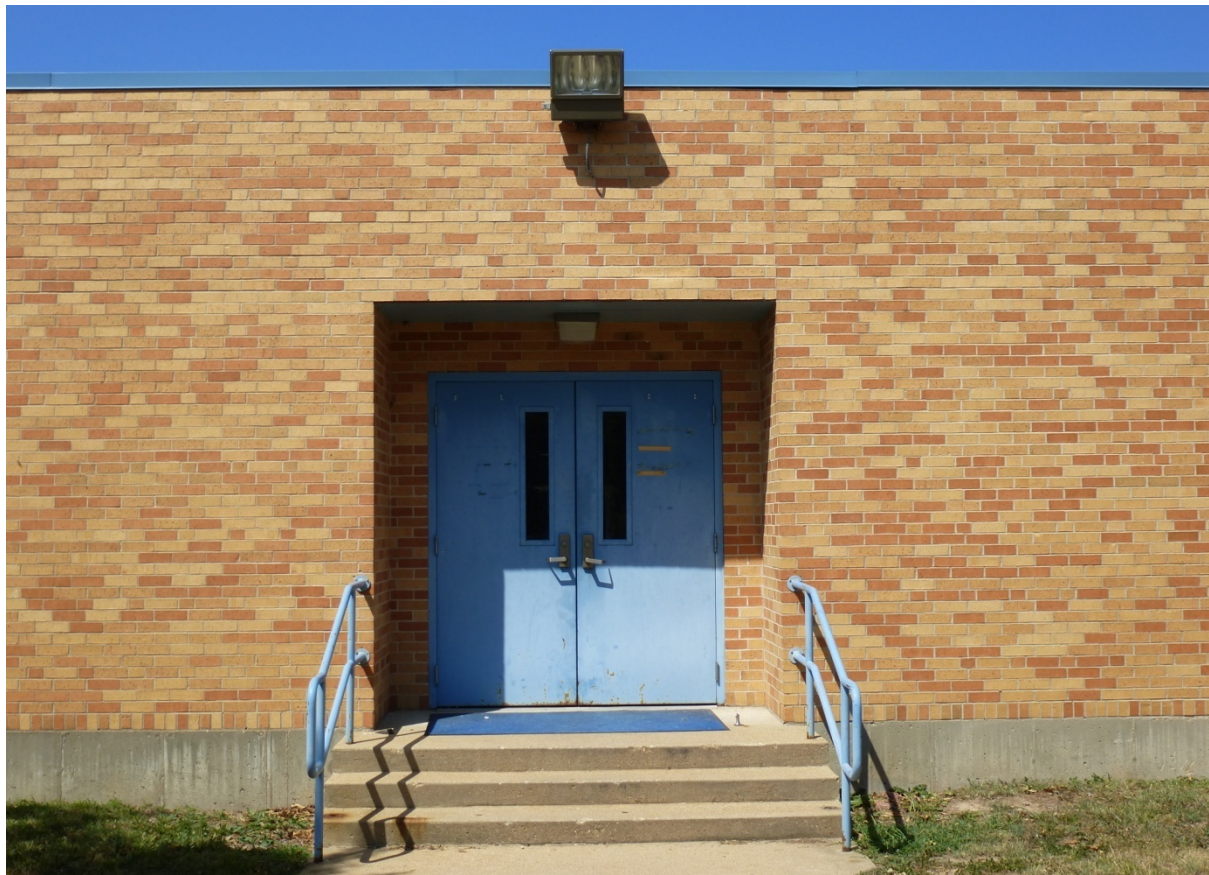
Photo 45. Entry doors on the east elevation of the 1984 addition (ERDC-CERL, 2012).

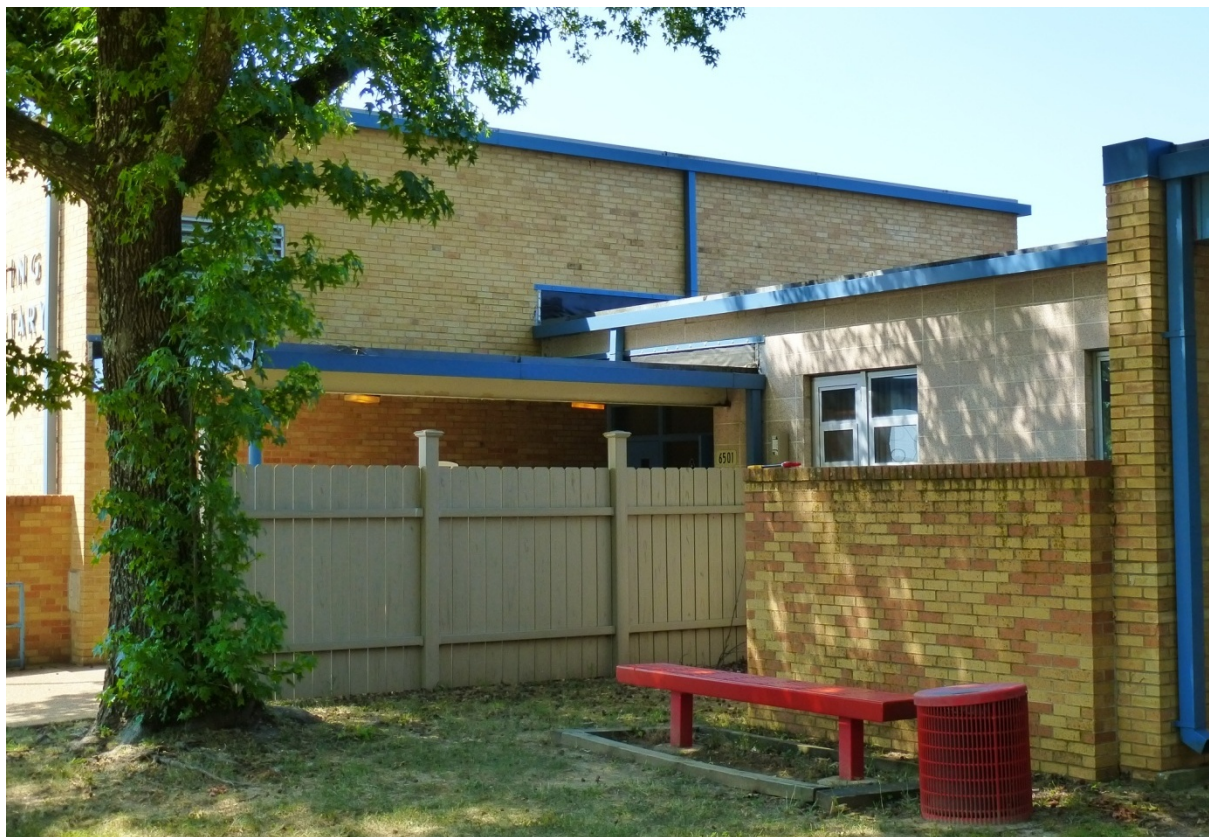
Photo 50. Looking toward the main entry on the east elevation (ERDC-CERL, 2012).

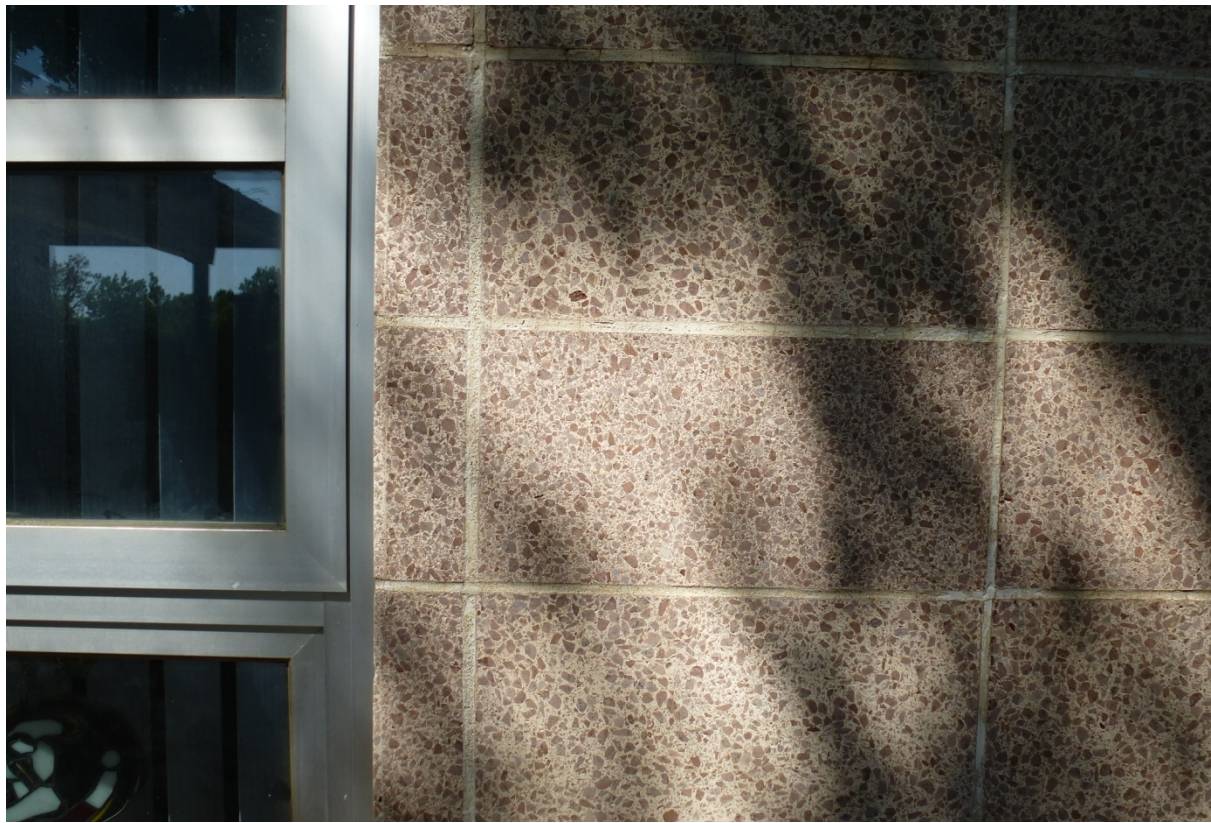
Photo 51. Original terrazzo faced block near the main entry on the east elevation (ERDC-CERL, 2012).

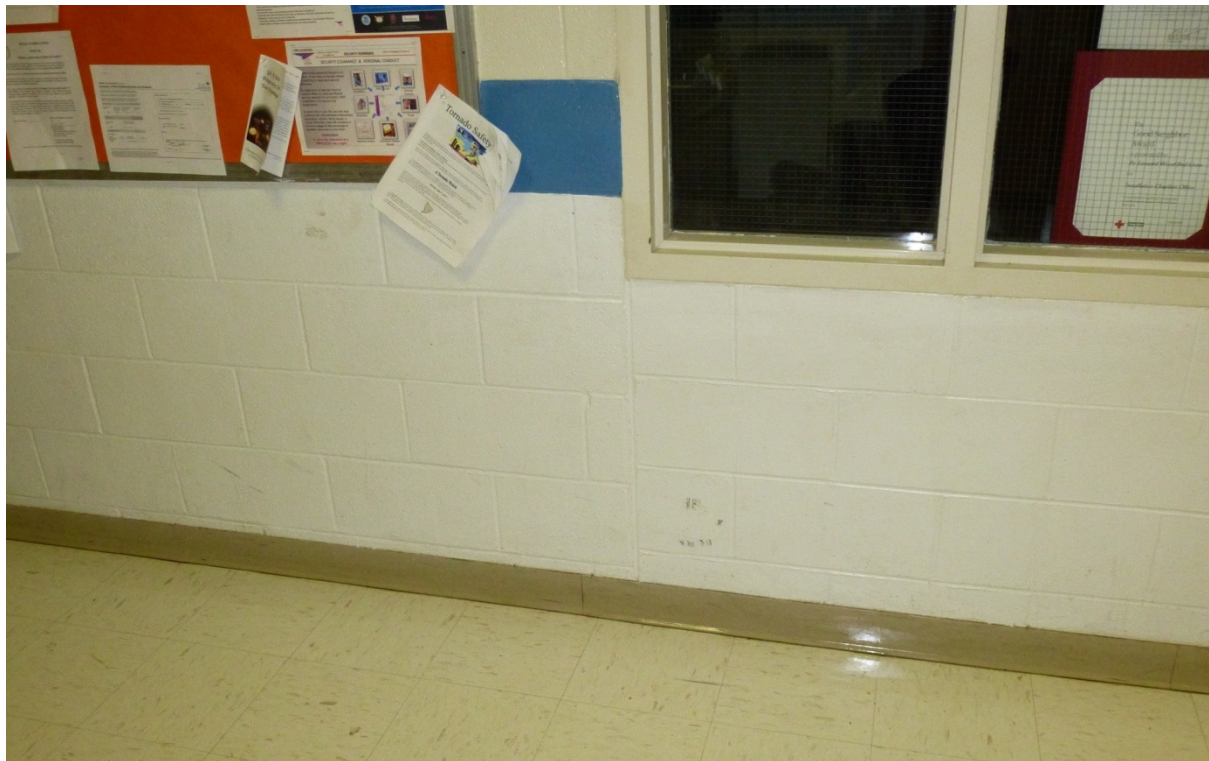
Photo 55. Closeup of the seam between original concrete block interior wall (left) and concrete block infill wall from 1984 remodel of office area (right) (ERDC-CERL, 2012).

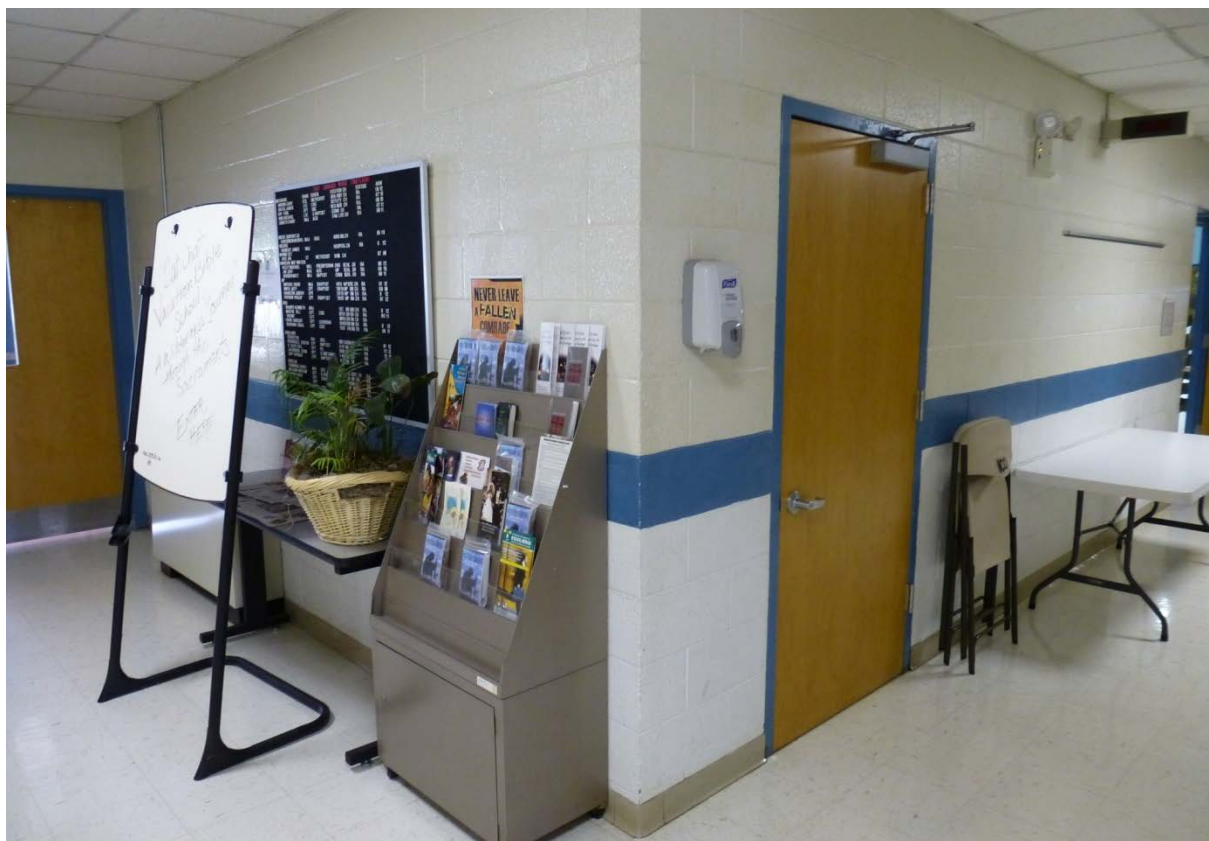
Photo 56. Concrete block interior walls and replacement wood door into the stage steps (original school) (ERDC-CERL, 2012).

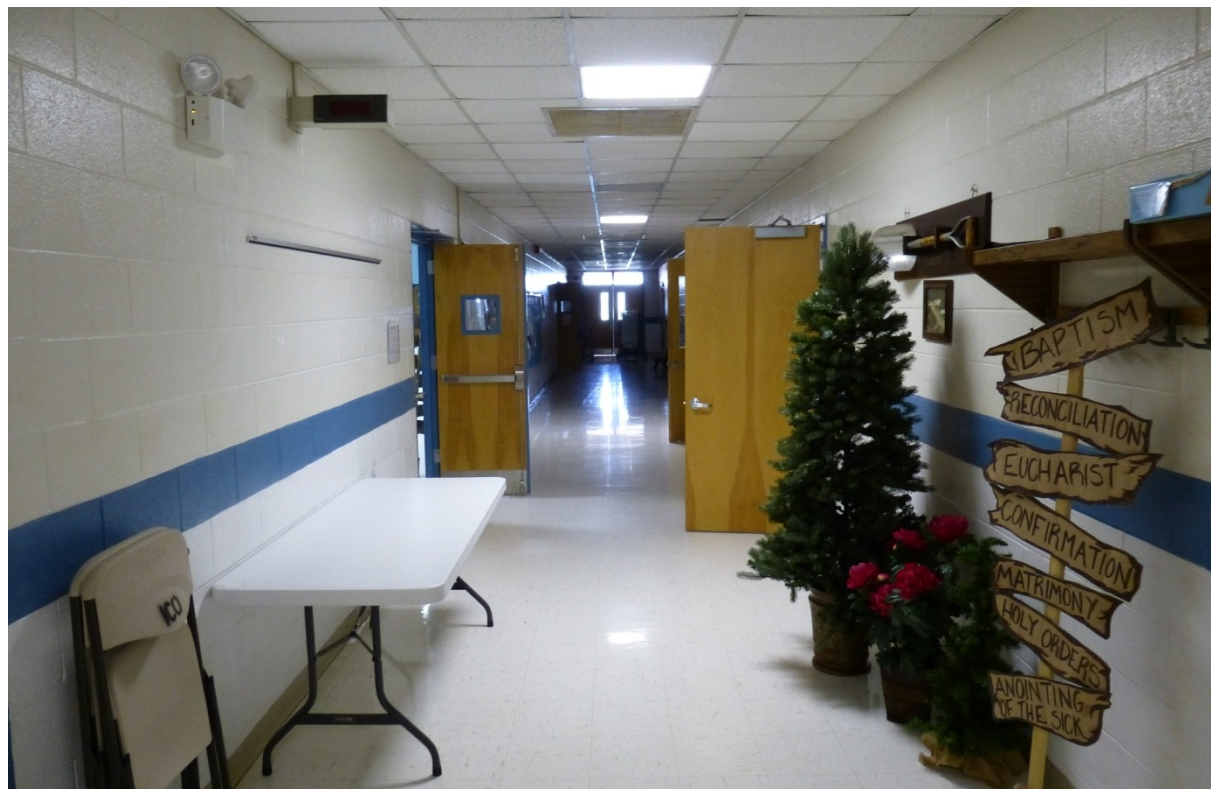
Photo 58. Looking south down original corridor (original school) (ERDC-CERL, 2012).

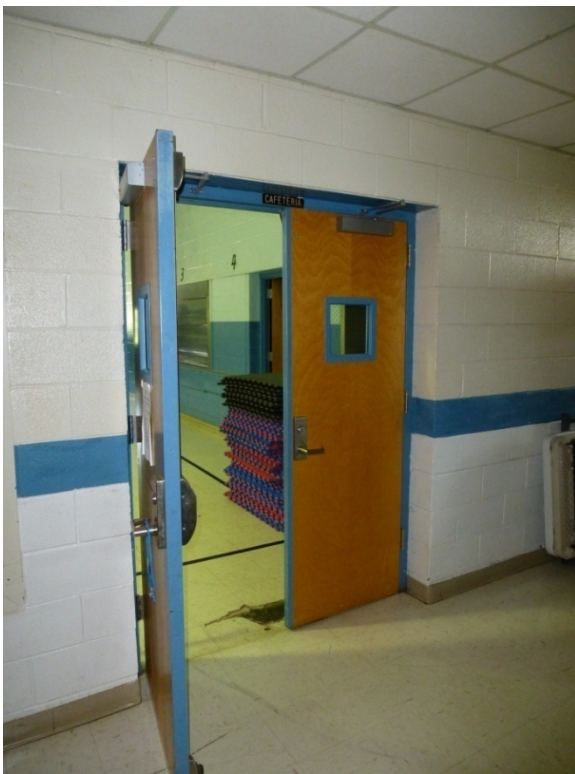
Photo 60. Replacement wood doors into the multi-purpose room (original school) (ERDC-CERL, 2012).

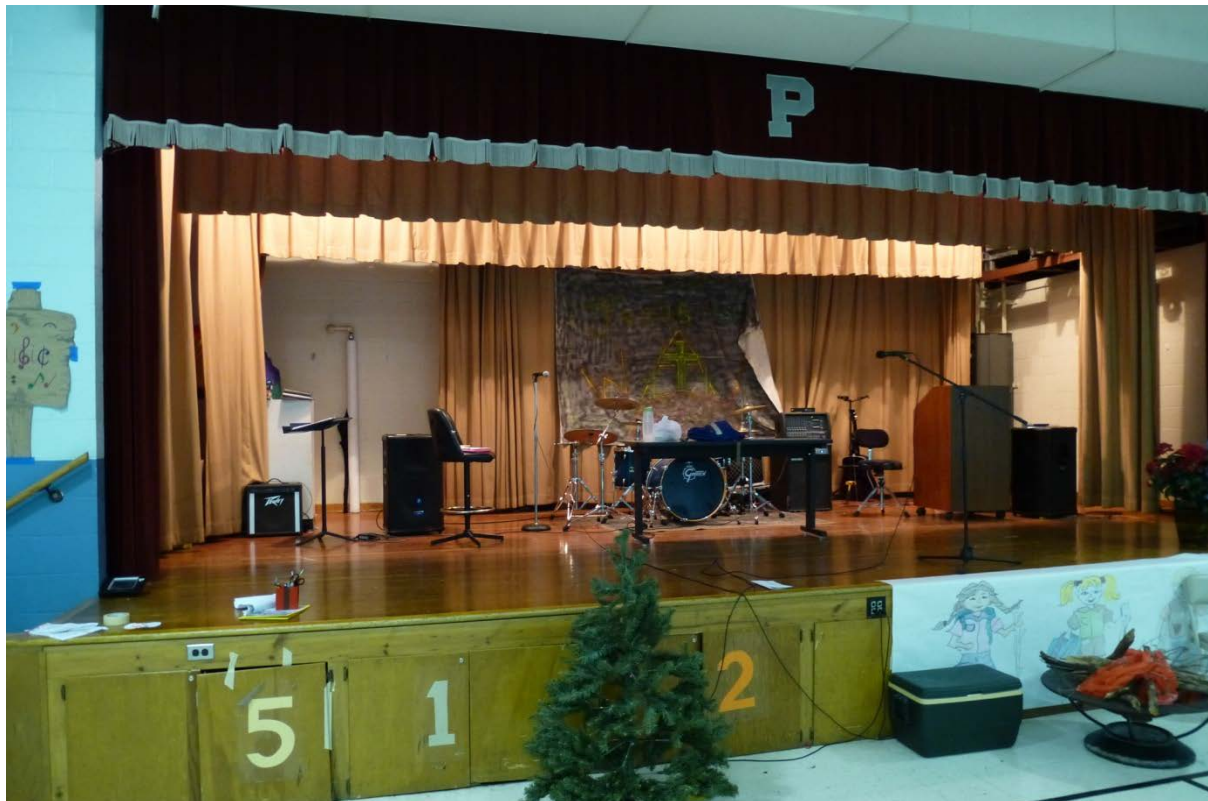
Photo 61. Original stage with original wood floor in the multi-purpose room (original school) (ERDC-CERL, 2012).
